Ceramic Supergrade Case Study

Metal Machinery Repair Saves \$60 million

A three week lead time replacing damaged metal machinery at a Ball Mill in Puerto Rico looked set to cost a company \$60 million in lost revenue – until Sylmasta Ceramic Supergrade carried out a repair in under 24 hours

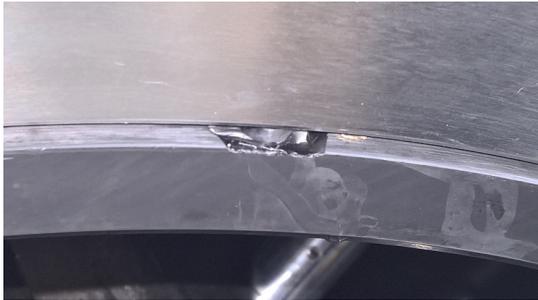
Significant crack in the machine part caused when maintenance work was carried out

During maintenance work at the Ball Mill, a part had been forced, causing a significant crack to a metal part on the outside of the machine through which water was leaking into the inside shell.

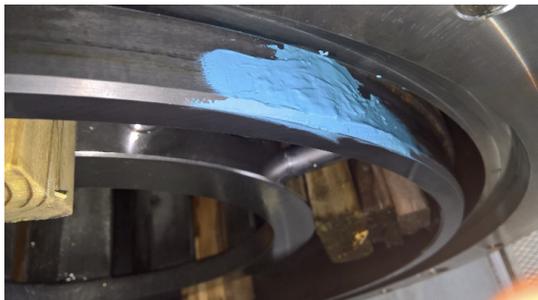
Ceramic Brushable epoxy paste applied to fill in and seal the crack in the machinery

The Ball Mill instead carried out a repair using **Ceramic Supergrade**, a two-part epoxy paste reinforced with silicon carbide for ultimate surface hardness manufactured for the repair and refurbishment of heavy machinery.

Ceramic Supergrade was applied with a trowel, spread over and pushed into the crack to provide a hard-wearing, abrasion resistant filler to repair the damage.

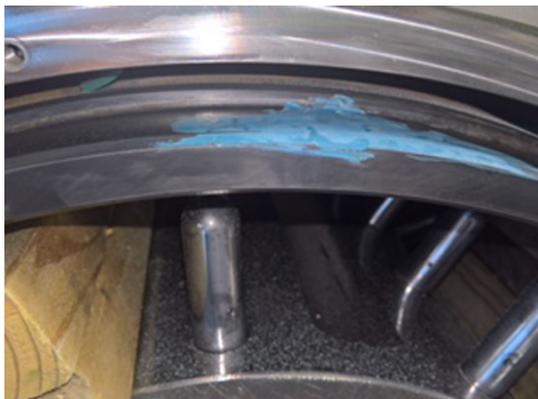
Epoxy paste during the curing process

The repair was carried out on a Sunday whilst the site was shut for the weekend. Ceramic Supergrade has a full cure time of 24 hours.

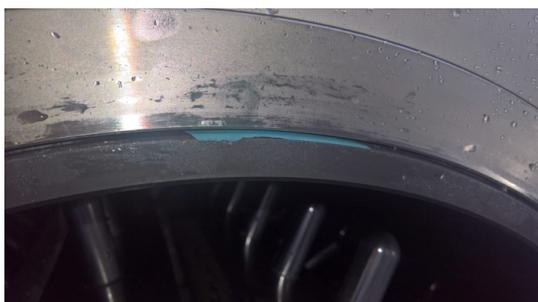
The completed repair with the outer ring fitted back onto the machine

When the Ball Mill reopened for business on the Monday, it was operating at full capacity with tens of millions of dollars saved.
